RWP2- Polytron Oil test Client's Testimonies x

## RAW WATER PUMP 2 - POLYTRON OIL TESTING ON NOVEMBER 20, 2018

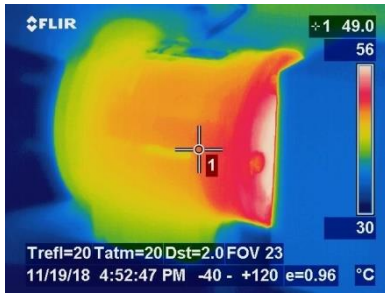
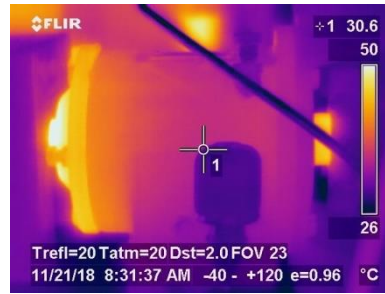
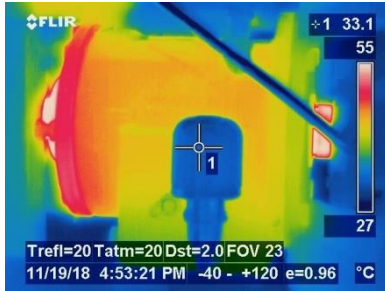
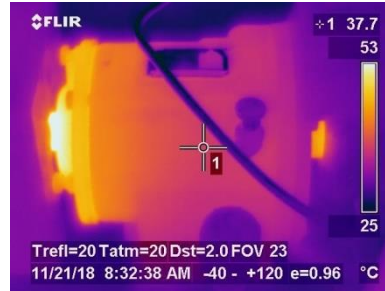
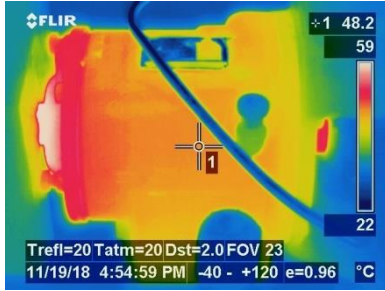
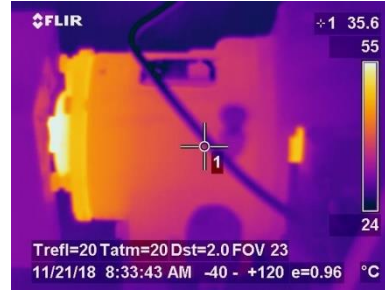
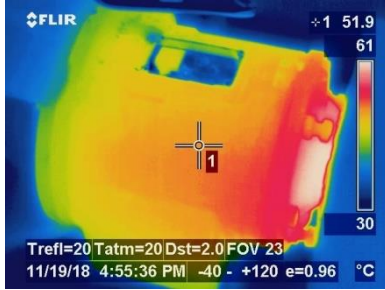
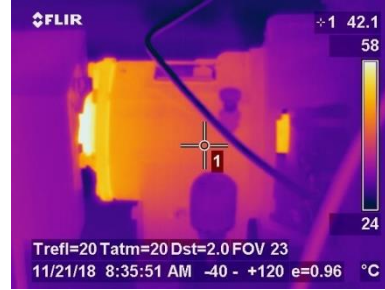
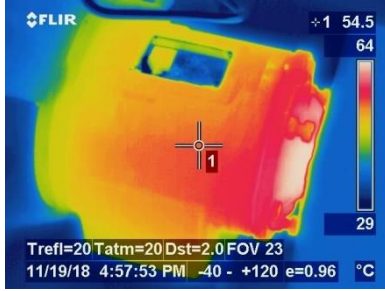
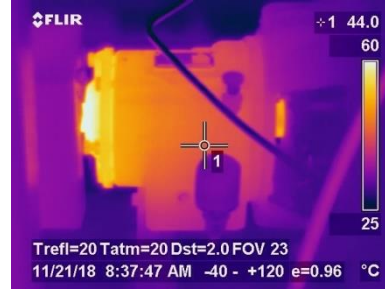
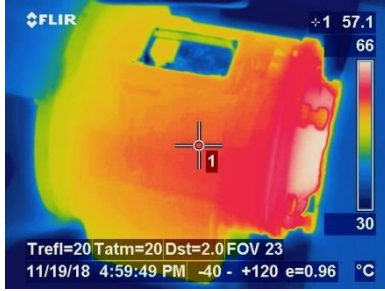
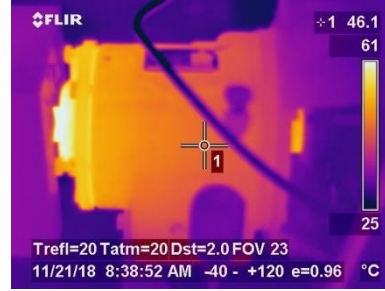
Testing was conducted due to excessive heat generation of the pump because of internal rubbing of parts/bearings.

Before the testing, maximum temperature of the pump was 66 C and the body temperature is around 57 C. No repair was done on the pump, only changed the oil with new one and

After applying POLYTRON oil on the pump, maximum temperature is 61 C while the body temperature is 46.1 C.

As per result, there is a significant change in temperature after using the oil.

mixed with 1 bottle (473 ml) of POLYTRON OIL product.
